Property Inspection Report

, Sample Report, TX
Inspection prepared for:
Date of Inspection: 8/9/2022
Age of Home: 56 Size: 3270

PROPERTY INSPECTION REPORT FORM

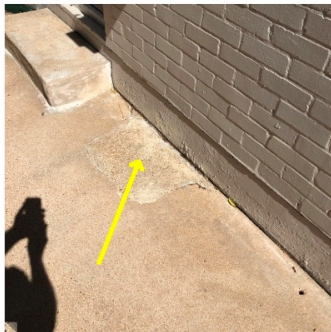
Patched concrete, Exterior Right. Size, shape, and location of patch were consistent with possible previous foundation repair. Recommend Buyer ask Seller about any known foundation repair.

Patched concrete, Exterior Right.

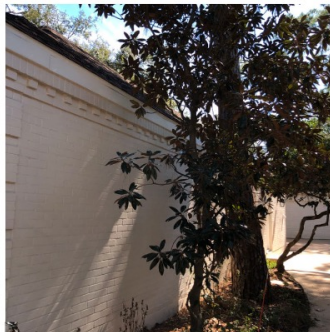
Trees in close proximity to foundation. Vegetation near the foundation can remove soil moisture, leading to foundation movement. Large trees may have roots that directly damage foundation. A root barrier may help protect foundation from tree roots; unable to determine if a root barrier was present at time of the inspection.

Tree in close proximity to foundation.

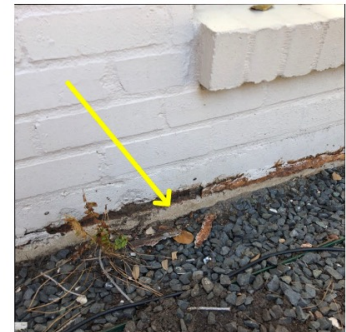
Damaged foundation or slab. Exterior Rear

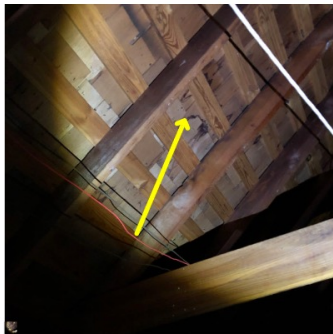
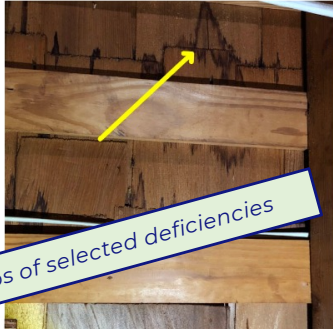
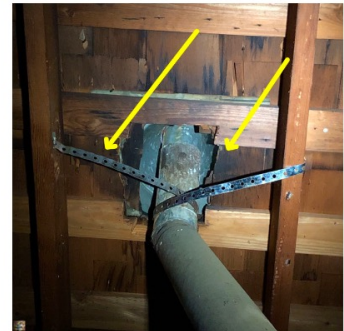
Evidence of water penetration: multiple stains observed on underside of roofing and at vent penetration(s).

Stains on underside of roofing. Multiple locations. Unknown if active leaks present.

Stains on underside of roofing.

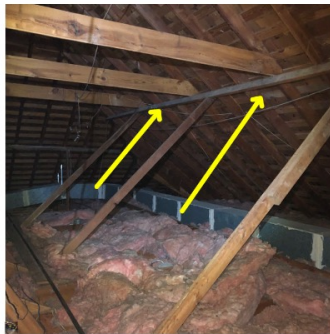
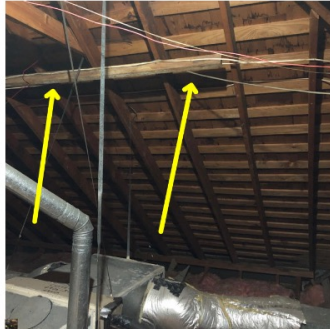
Any or all of these deficiencies were observed: purlins smaller than the supported rafters, purlin brace(s) missing, rafter heels falling below ridge beam. These were typical for the age of the home but did not meet current standards.

Missing purlin brace(s).

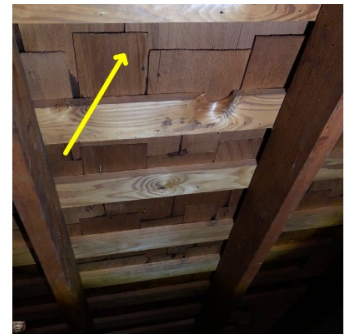
Wood shakes/shingles over slats observed from attic. Roof covering was composition shingles. Current standards and shingle manufacturers recommend composition shingles be installed on solid sheathing (plywood or OSB) directly attached to roof framing. Composition shingles should not be installed over wood shingles/shakes.

Wood shakes/shingles.

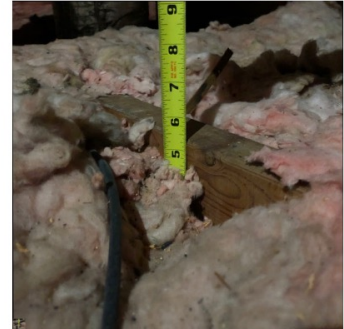
Missing or inadequate insulation. Amount of insulation observed did not meet current standards. Lack of insulation may promote movement of conditioned air into attic space, leading to higher energy costs and possible damage due to condensation.

Insulation depth.

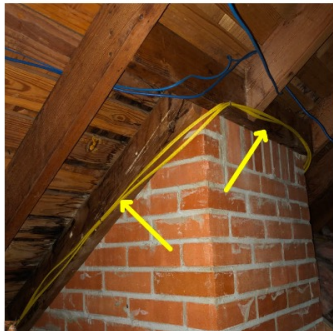
Wood framing improperly in contact with chimney. Current standards recommend wood members be separated from chimneys to minimize risk of fire.

Wood framing improperly in contact with chimney.

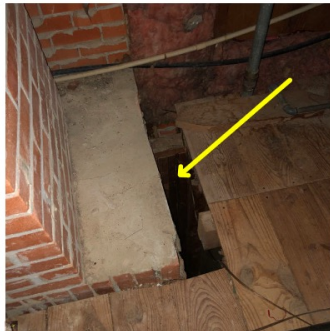
Opening not firestopped or insulated. Attic.

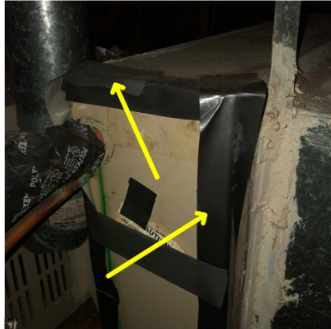
Improper tape on evaporator and refrigerant line.

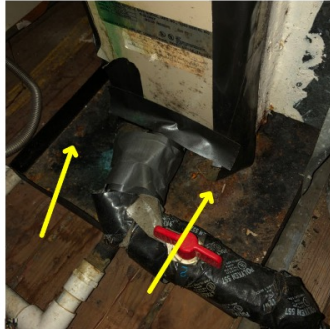
Corrosion and/or debris in the condensate drain pan.

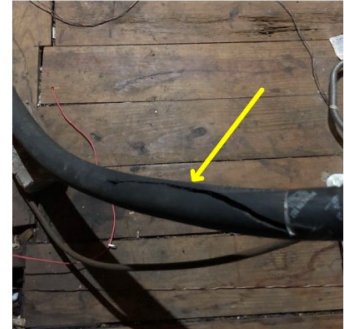
Missing or damaged insulation at refrigerant line(s).

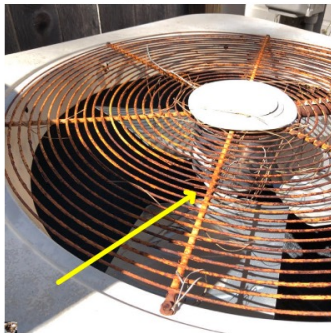
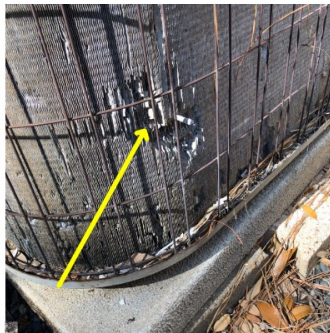
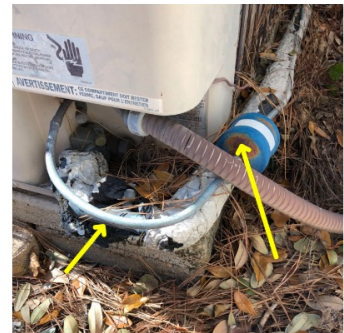
Corrosion and damage on condensing unit.
